EPDM: A PROVEN PERFORMER

Long-term weathering study shows 30-year roofs continue to perform well.

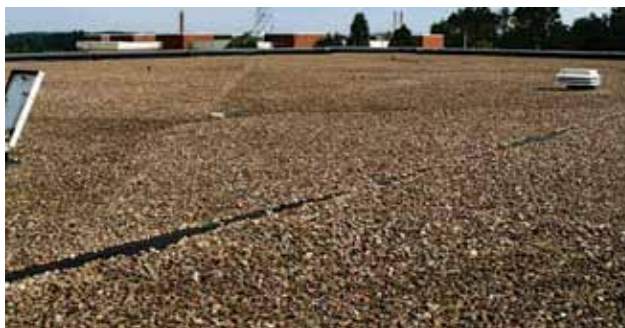
The 29-year-old EPDM roof protecting the Jamerich Building at Northern Michigan University in Marquette, Mich., is still performing well.
